Appendix D: Photographs of assessed reaches.

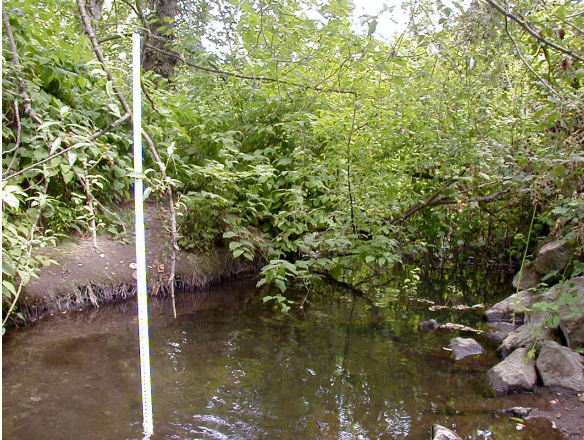
Segment 1. Bank armoring and trampling was typical in this segment. Blackberry vines (*Rubus laciniatus*) were also abundant.

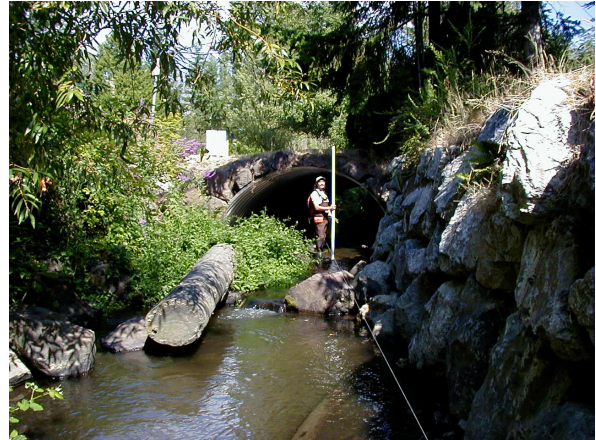
Segment 1. Culvert at NE 120th Street. Armoring typical of this segment.

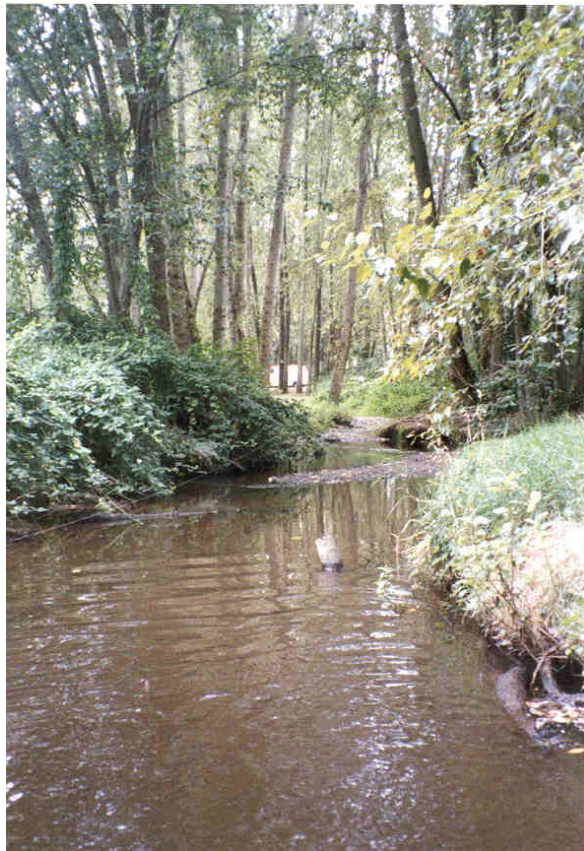
Segment 2. This photo is taken looking downstream toward NE 124th Street. Note the large amount of sediment aggradation, and invasives in the riparian zone.

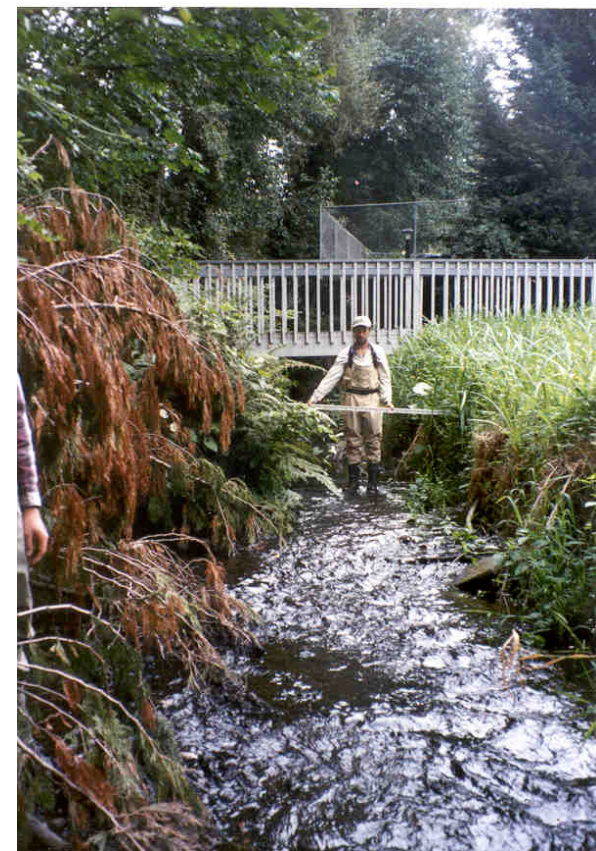
Segment 2. Residential encroachment on the riparian zone and channelized stream reaches were typical in this segment. A large piece of wood on the right bank was viewed as an eyesore and a hazard by adjacent property owners.

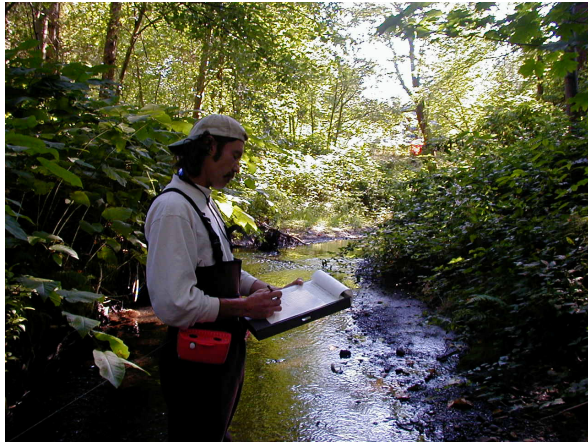
Segment 3. The stream margins are dominated by invasives at this site, blackberry vines on the right, and Japanese knotweed (*Polygonum cuspidatum*) on the left.

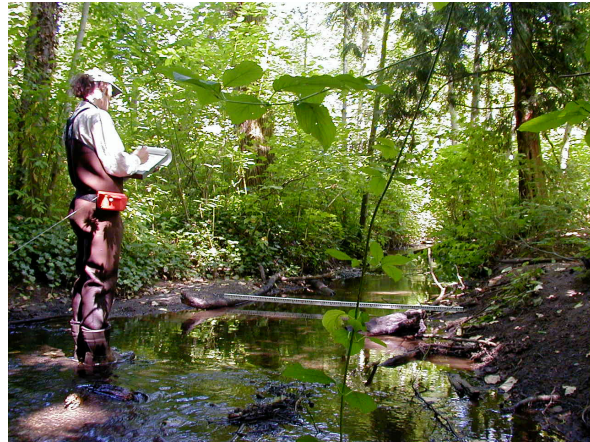
Segment 4. Little LWD, and compacted stream bank characterize this reach.

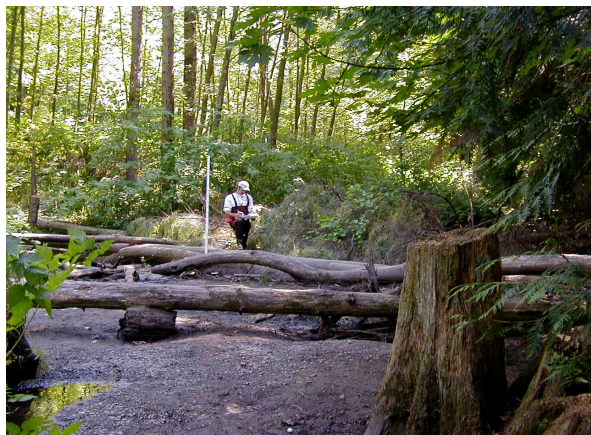
Segment 4. Large amount of sediment aggradation, scoured stream bank with LWD in the oversized stream channel may point to high discharges.

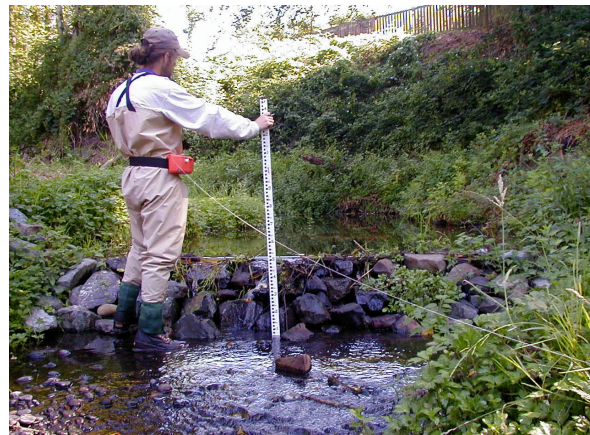
Segment 5. Residential encroachment on the riparian buffer can lead to increased access and alteration to the channel.

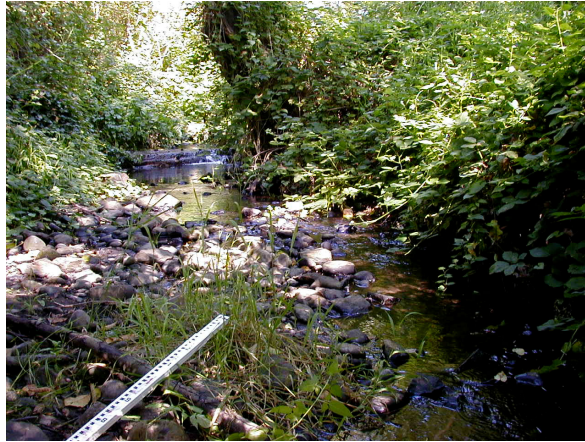
Segment 5. Riparian buffer appears to be well vegetated in this reach, and contains a considerable blackberry vine component.
